**Flood Control Project Maintenance
Levee Inspections**

Maintenance Issue Types Only, Levee Inspection Report By Mile - Fall 2014

Reclamation District No. 2062 Stewart

Waterway	Bank	Unit Miles	Inspection Start/End	Inspector
Unit No. 01 San Joaquin River	Left	2.64	11/21/2014 11/21/2014	Maksim Khashchuk

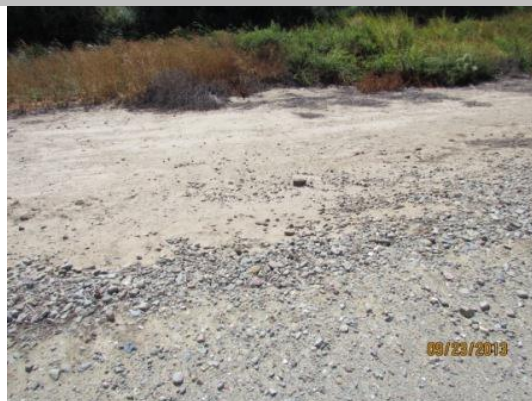
Photo 1 of 1 : FA_2014_RD2062_310_14_20141001_00008.jpg

LM Start	3.03	Rating **	N	Issue No.	14
LM End	3.03	Issue Type +	Ma	Location *	WS
Category	Earthen Levee			GPS Latitude/Longitude	
				Start	End
Item	Trim / Thin Trees			37.804452 °	37.804452 °
				-121.374903 °	-121.374903 °
DWR ID	DWR_RD2062_02_s_2012_14				
Action/Comments					
Tree stumps.

View of the tree stump in the middle of the photo.

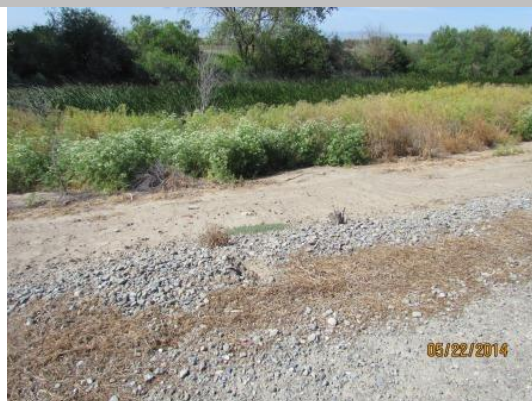
Photo 1 of 1 : FA_2014_RD2062_310_15_20141001_00009.jpg

LM Start	3.07	Rating **	N	Issue No.	15
LM End	3.07	Issue Type +	Ma	Location *	WS
Category	Earthen Levee			GPS Latitude/Longitude	
				Start	End
Item	Trim / Thin Trees			37.804481 °	37.804481 °
				-121.375510 °	-121.375510 °
DWR ID	DWR_RD2062_02_s_2012_15				
Action/Comments					
Tree stumps.

View of the tree stumps on the waterside levee slope.

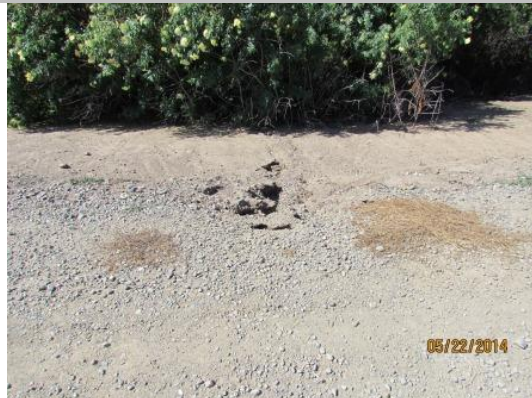
Photo 1 of 1 : FA_2014_RD2062_310_8_20141001_00004.jpg

LM Start	3.71	Rating **	M	Issue No.	8
LM End	3.71	Issue Type +	Ma	Location *	WS
Category	Earthen Levee			GPS Latitude/Longitude	
				Start	End
Item	Erosion / Bank Caving			37.806347 °	37.806347 °
				-121.386692 °	-121.386692 °
DWR ID	DWR_RD2062_02_s_2014_8				
Action/Comments					
Schedule repair of erosion site prior to the next inspection.

View of the erosion from surface runoff on the waterside levee slope.

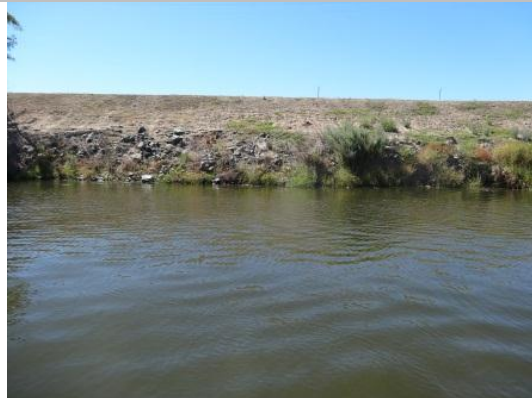
Photo 1 of 1 : SJR2014_RD2062U03RM30.1_1.jpg

LM Start	0.18	Rating **	M	Issue No.	4
LM End	0.18	Issue Type +	Ma	Location *	WS
Category	Supplemental			GPS Latitude/Longitude	
				Start	End
Item	DWR Erosion Survey			37.810468 °	37.810468 °
				-121.387492 °	-121.387492 °
DWR ID					
Action/Comments					
Inspector Comments: 07/02/2014: No significant change observed. 08/13/2013: No significant change observed. 08/07/2012: The site has been visited by boat survey. No significant change observed 08/23/2011: The protection at the levee toe has been washed away. [2014 Site ID:RD2062U03RM30.1]

Direct view of the site.

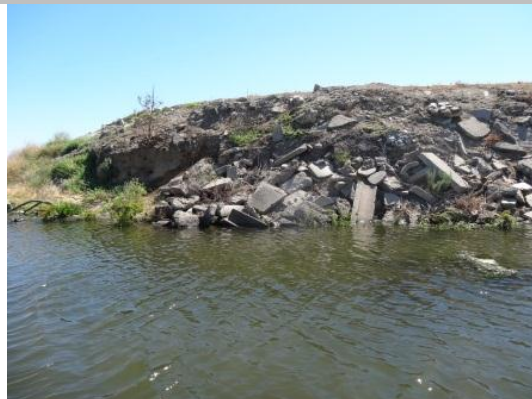
Photo 1 of 1 : SJR2014_RD2062U03RM30.43_1.jpg

LM Start	0.56	Rating **	M	Issue No.	9
LM End	0.57	Issue Type +	Ma	Location *	WS
Category	Supplemental			GPS Latitude/Longitude	
				Start	End
Item	DWR Erosion Survey			37.813070 °	37.813070 °
				-121.383100 °	-121.383100 °
DWR ID					
Action/Comments					
Inspector Comments: 07/02/2014: No significant change observed. 08/13/2013: No significant change observed. 08/07/2012: The site has been visited by boat survey. No significant change observed. 08/23/2011: No significant change observed on site. 09/07/2010: No significant change observed on site. Much of the placed rip rap revetment has slid. It is no longer adequately protecting the slope. 08/06/2010: Recommended as local maintenance issue, per CLRO Report. 03/09/2010: As discussed with Michael Moncrief of MBK, site will be 'addressed' this year. 09/29/2009: No major change observed since last visit; a section of the rip rap has slipped, exposing a levee section that has eroded; recommended as local maintenance issue, per CLRO CES Evaluation 2008 Report; Site # is the same as RM30.43,LM0.63; previously rated "U". 11/05/2008: Site is located inside of a bend; scarp looks to be into the levee prism; piles of concrete chunks placed on the slope, with some of them already starting to slide. [2014 Site ID:RD2062U03RM30.43]

Front view of the site. Rip rap no longer adequately protecting levee slope.

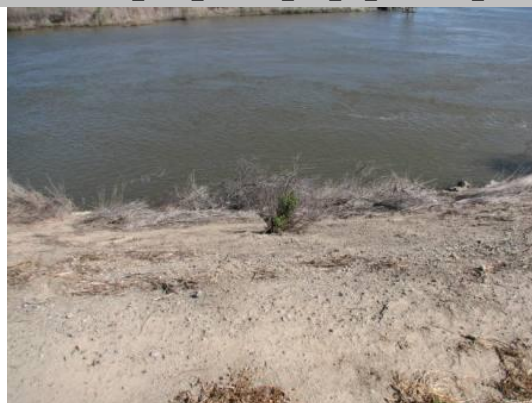
Photo 1 of 1 : FA_2014_RD2062_311_10_20141001_00009.jpg

LM Start	0.61	Rating **	N	Issue No.	10
LM End	0.61	Issue Type +	Ma	Location *	WS
Category	Earthen Levee			GPS Latitude/Longitude	
				Start	End
Item	Trim / Thin Trees			37.813570 °	37.813570 °
				-121.382094 °	-121.382094 °
DWR ID	DWR_RD2062_03_s_2012_10				
Action/Comments					
Tree stumps.					
Inspector Comments: Stump in slope.

05/11/2011 Stump in slope, new growth in center of photo is at the location of the stump.

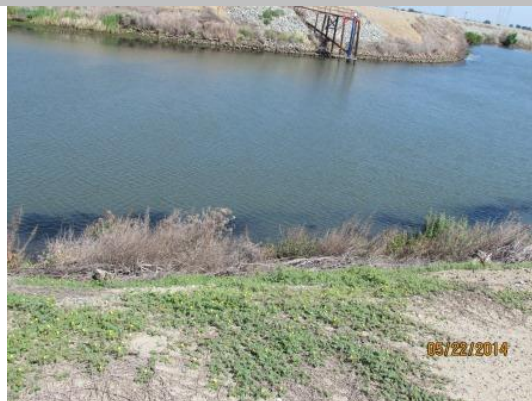
Photo 1 of 1 : FA_2014_RD2062_311_12_20141001_00012.jpg

LM Start	0.65	Rating **	N	Issue No.	12
LM End	0.65	Issue Type +	Ma	Location *	WS
Category	Earthen Levee			GPS Latitude/Longitude	
				Start	End
Item	Trim / Thin Trees			37.813894 °	37.813894 °
				-121.381680 °	-121.381680 °
DWR ID	DWR_RD2062_03_s_2012_12				
Action/Comments					
Tree stumps.					
Inspector Comments: 2 stumps on waterside slope.

View of the tree stumps on the waterside levee slope.

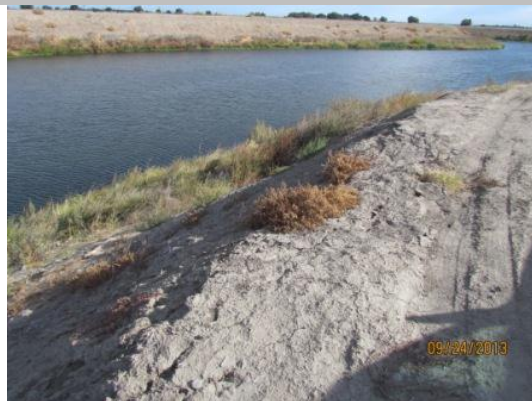
Photo 1 of 2 : FA_2014_RD2062_311_11_20141001_00010.jpg

LM Start	0.82	Rating **	A/W	Issue No.	11
LM End	0.82	Issue Type +	Ma	Location *	WS
Category	Earthen Levee			GPS Latitude/Longitude	
				Start	End
Item	Erosion / Bank Caving			37.816315 °	37.816315 °
				-121.381587 °	-121.381587 °
DWR ID	DWR_RD2062_03_s_2012_11				
Action/Comments					
Schedule repair of erosion site prior to the next inspection. Inspector Comments: Cracking developing along the waterside levee hinge.

View of cracking at waterside levee hinge.

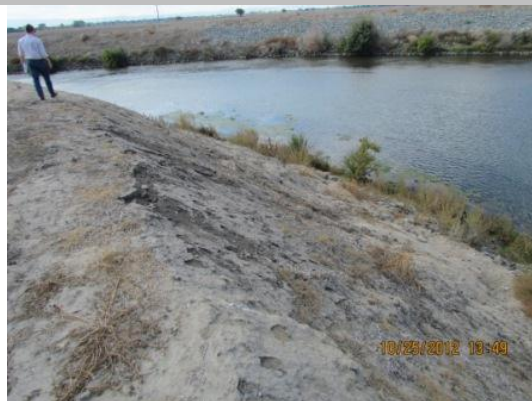
Photo 2 of 2 : FA_2014_RD2062_311_11_20141001_00011.jpg

LM Start	0.82	Rating **	A/W	Issue No.	11 (cont)
LM End	0.82	Issue Type +	Ma	Location *	WS

View of slope erosion from foot traffic.

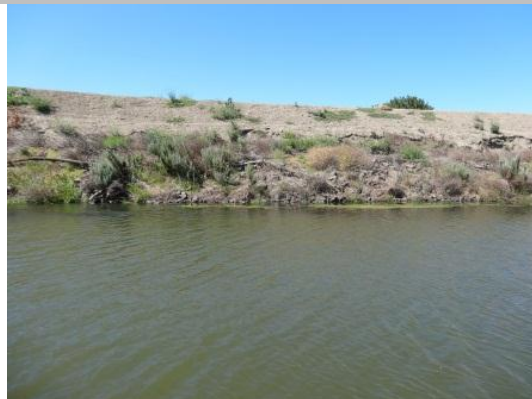
Photo 1 of 1 : SJR2014_RD2062U03RM31.12_1.jpg

LM Start	1.20	Rating **	U	Issue No.	13
LM End	1.21	Issue Type +	Ma	Location *	WS
Category	Supplemental			GPS Latitude/Longitude	
				Start	End
Item	DWR Erosion Survey			37.819290 °	37.819290 °
				-121.378880 °	-121.378880 °
DWR ID					
Action/Comments					
Inspector Comments: 07/02/2014: No significant change observed. 08/13/2013: No significant change observed. 08/07/2012: The site has been visited by boat survey. No significant change observed 08/23/2011: No significant change observed on site. 09/07/2010: No significant change observed on site. Much of the

Front view of the site.

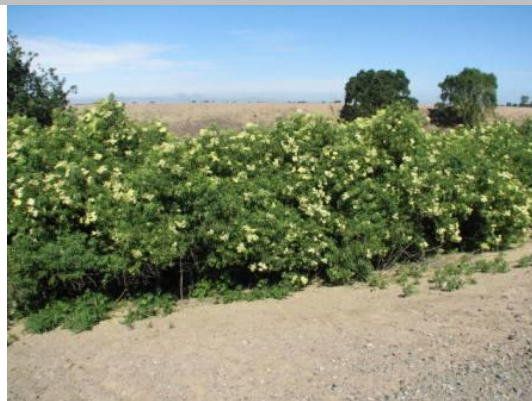
Photo 1 of 1 : FA_2014_RD2062_311_18_20141001_00015.jpg

LM Start	1.37	Rating **	A/W	Issue No.	18
LM End	1.37	Issue Type +	Ma	Location *	WS
Category	Earthen Levee			GPS Latitude/Longitude	
				Start	End
Item	Vegetation			37.820885 °	37.820885 °
				-121.376986 °	-121.376986 °
DWR ID	DWR_RD2062_03_s_2012_18				
Action/Comments					
Elderberries are blocking visibility and flood fight capability. Inspector Comments: Elderberry bush blocks visibility.

05/11/2011 Elderberry bush on water side slope.

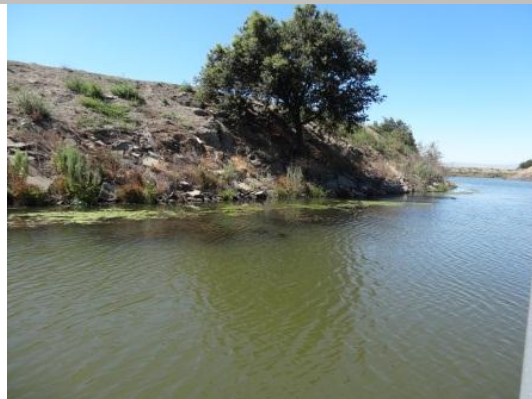
Photo 1 of 1 : SJR2014_RD2062U03RM31.28_1.jpg

LM Start	1.42	Rating **	U	Issue No.	20
LM End	1.43	Issue Type +	Ma	Location *	WS
Category	Supplemental			GPS Latitude/Longitude	
				Start	End
Item	DWR Erosion Survey			37.821380 °	37.821380 °
				-121.376900 °	-121.376900 °
DWR ID					
Action/Comments					
Inspector Comments: 07/02/2014: No significant change observed. 08/13/2013: No significant change observed. 08/07/2012: The site has been visited by boat survey. No significant change observed 08/23/2011: No significant change observed on site. 09/07/2010: No significant change observed on site. There is a small-to medium sized Oak tree on the mid-slope just above rip rap. Some of the rip rap has collapsed, creating a pocket erosion just above the existing toe rip rap and upstream of the Oak tree. 08/06/2010: Recommended as local maintenance issue, per CLRO. 03/09/2010: As discussed with Michael Moncrief of MBK Engineer, site will be 'addressed' in 2010. 09/29/2009: No major change since last visit; sliding of the rip rap at the base of the lone tree; there is noticeable man-made trail and foot traffic extending from the crown to the toe; much of the broken concrete used as temporary rip rap has slid, exposing portion of the bare levee slope; recommended as local maintenance issue, per CLRO CES Evaluation 2008 Report; Site # is the same as RM31.3, LM1.45; previously rated "M". 11/05/2008: Portion of rip rap collapsing. 09/14/2006: Portion of rip rap along the slope has collapsed; exposed levee section is starting to erode, exposing roots from the nearby tree. [2014 Site ID:RD2062U03RM31.28]

Front view of the site.

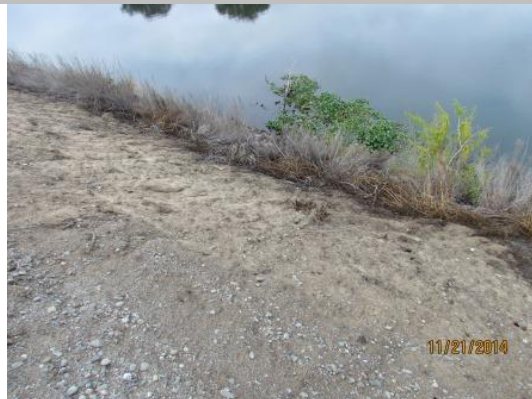
Photo 1 of 1 : FA_2014_RD2062_311_26_20141124_00027.jpg

LM Start	3.14	Rating **	N	Issue No.	26
LM End	3.14	Issue Type +	Ma	Location *	WS
Category	Earthen Levee			GPS Latitude/Longitude	
				Start	End
Item	Trim / Thin Trees			37.818532 °	37.818532 °
				-121.349510 °	-121.349510 °
DWR ID	DWR_RD2062_03_s _ 2012_26				
Action/Comments					
Tree stumps.

View of the tree stump on the waterside levee slope.

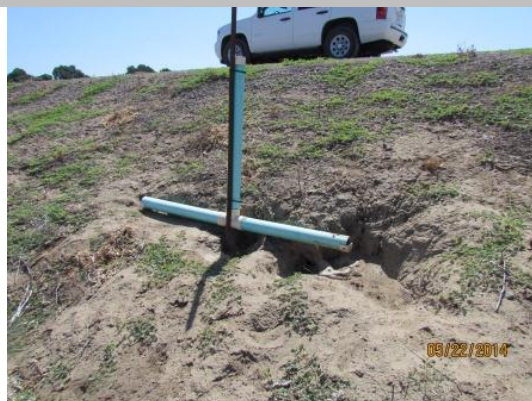
Photo 1 of 1 : FA_2014_RD2062_311_21_20141001_00018.jpg

LM Start	3.28	Rating **	A/W	Issue No.	21
LM End	3.28	Issue Type +	Ma	Location *	WS
Category	Earthen Levee			GPS Latitude/Longitude	
				Start	End
Item	Animal Control			37.820166 °	37.820166 °
				-121.348077 °	-121.348077 °
DWR ID	DWR_RD2062_03_s _ 2014_21				
Action/Comments					
No rodents visible, but rodent burrows visible; need to backfill and compact or grout burrows.					
Inspector Comments: LMA is actively controlling rodent population and is scheduling to backfill the holes prior to fall inspection.

View of the rodent holes on the waterside levee slope.

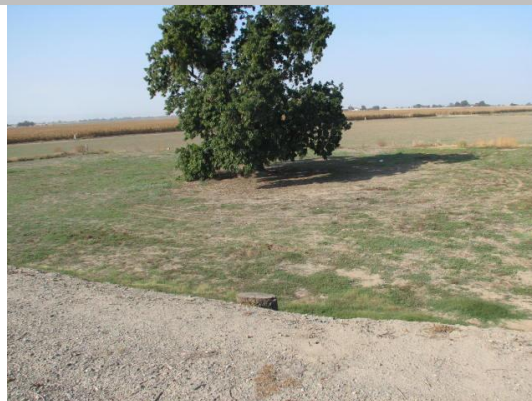
Photo 1 of 1 : FA_2014_RD2062_311_7_20141001_00006.jpg

LM Start	4.82	Rating **	N	Issue No.	7
LM End	4.82	Issue Type +	Ma	Location *	LS
Category	Earthen Levee			GPS Latitude/Longitude	
				Start	End
Item	Trim / Thin Trees			37.813986 °	37.813986 °
				-121.335821 °	-121.335821 °
DWR ID	DWR_RD2062_03_s_2012_7				
Action/Comments					
Tree stumps.					
Inspector Comments: 14" stump on landside slope.

10/21/2011 Photo taken the next day. Stump can be seen in the lower center of the photo.

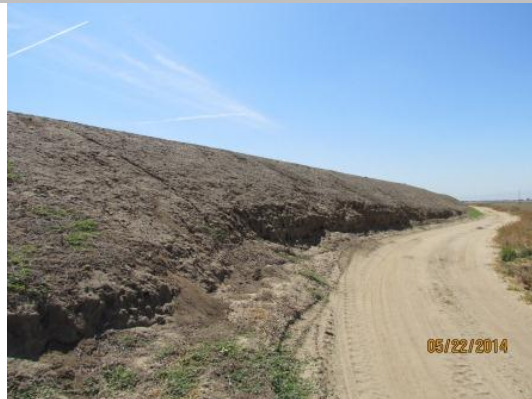
Photo 1 of 1 : FA_2014_RD2062_311_35_20141001_00020.jpg

LM Start	4.95	Rating **	M	Issue No.	35
LM End	4.95	Issue Type +	Ma	Location *	LS
Category	Earthen Levee			GPS Latitude/Longitude	
				Start	End
Item	Erosion / Bank Caving			37.812225 °	37.812225 °
				-121.336112 °	-121.336112 °
DWR ID	DWR_RD2062_03_f_2014_35				
Action/Comments					
Note and monitor erosion site. Inspector Comments: 2 to 3 feet vertical cut possibly caused by previous floods.

View of a 2-3 feet vertical cut at the landside levee toe.
